**A Historical and Architectural Study of
Three Rustic Structures at Giant Forest in Sequoia National Park
The Market, District Ranger's Residence, and Comfort Station**

Prepared by
C. Craig Frazier and Craig A. Kenkel
Historical Architects

**HISTORIC STRUCTURES REPORT
SEQUOIA NATIONAL PARK**

Approved
December 7, 1988

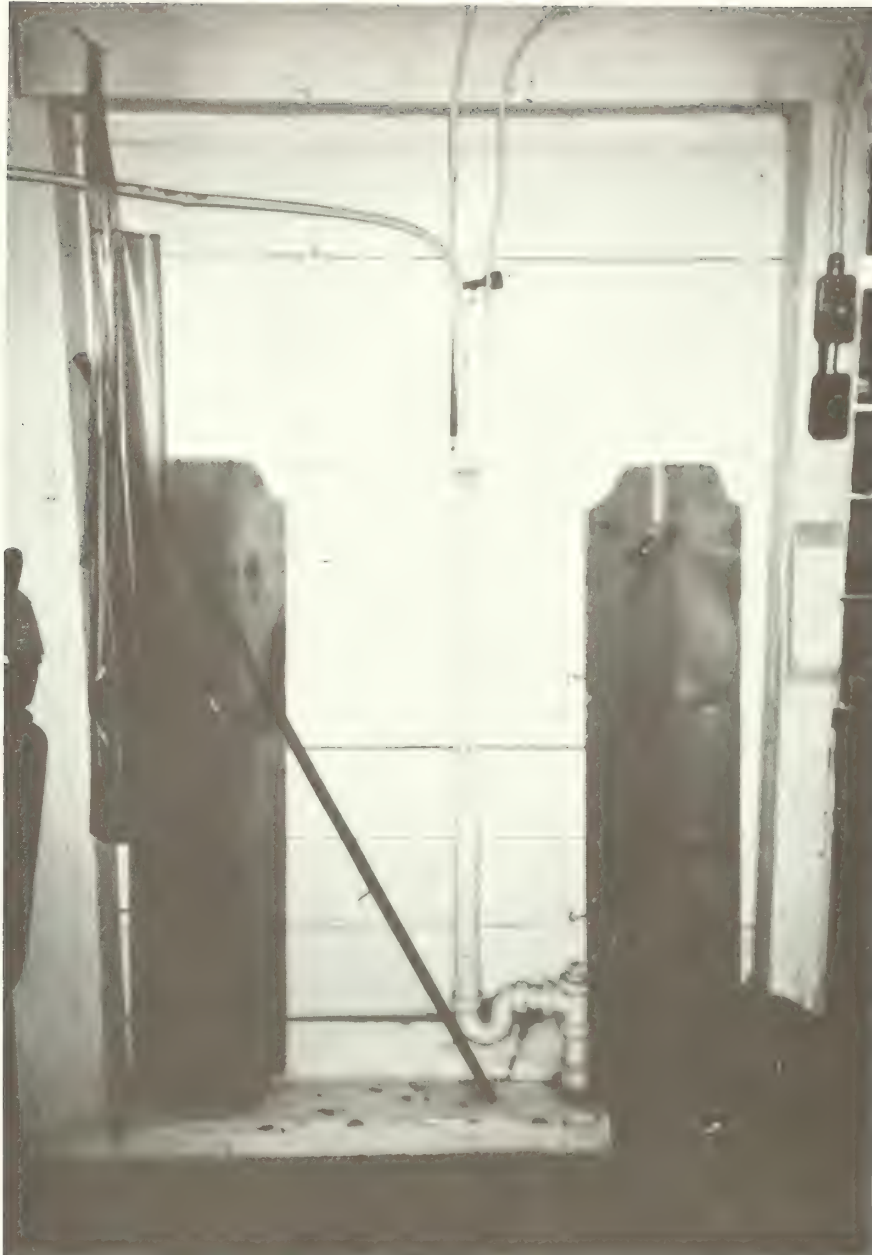
Figure D-2. Market--Condensation Drains from Walk-in Cooler (5/86).

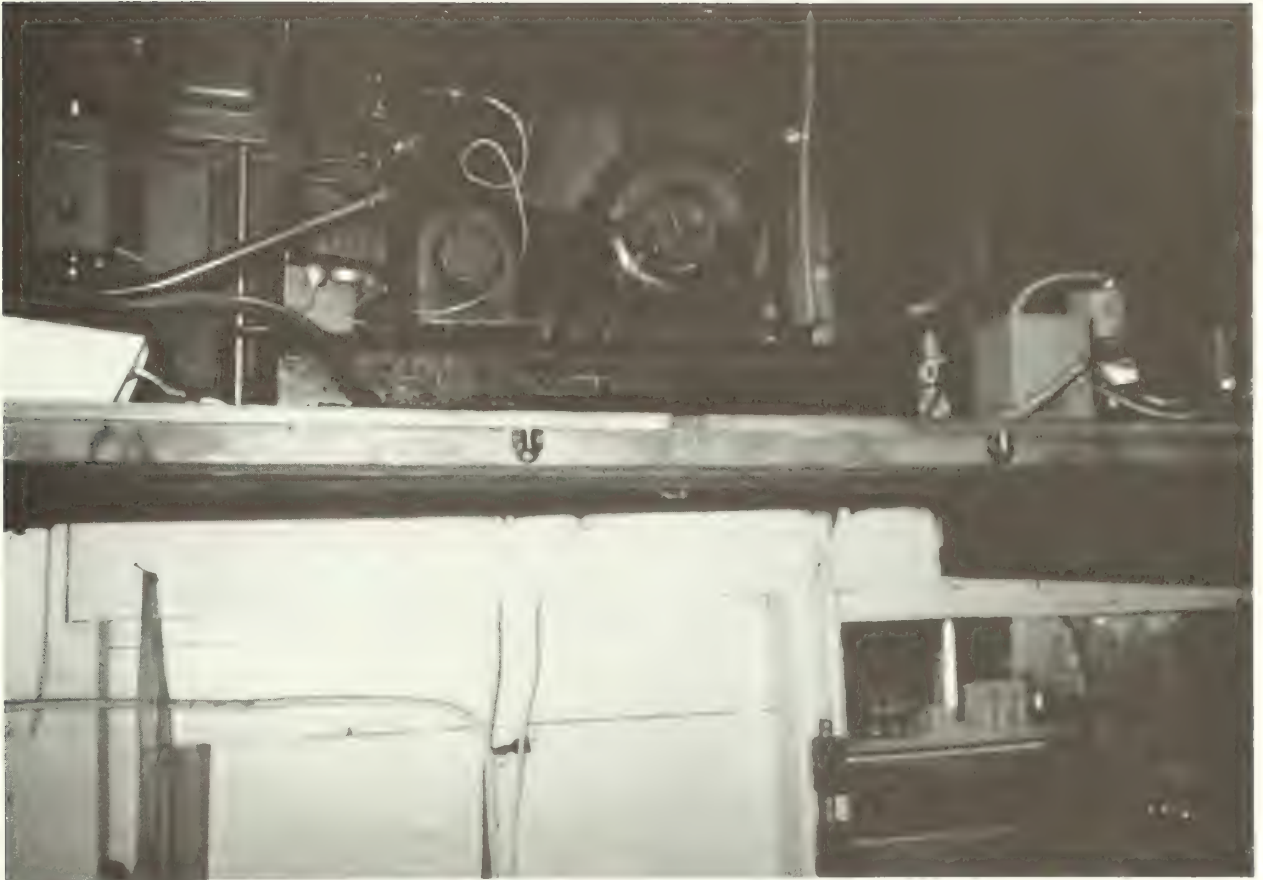
Figure D-3. Market--Walk-in Cooler Compressors (5/86).

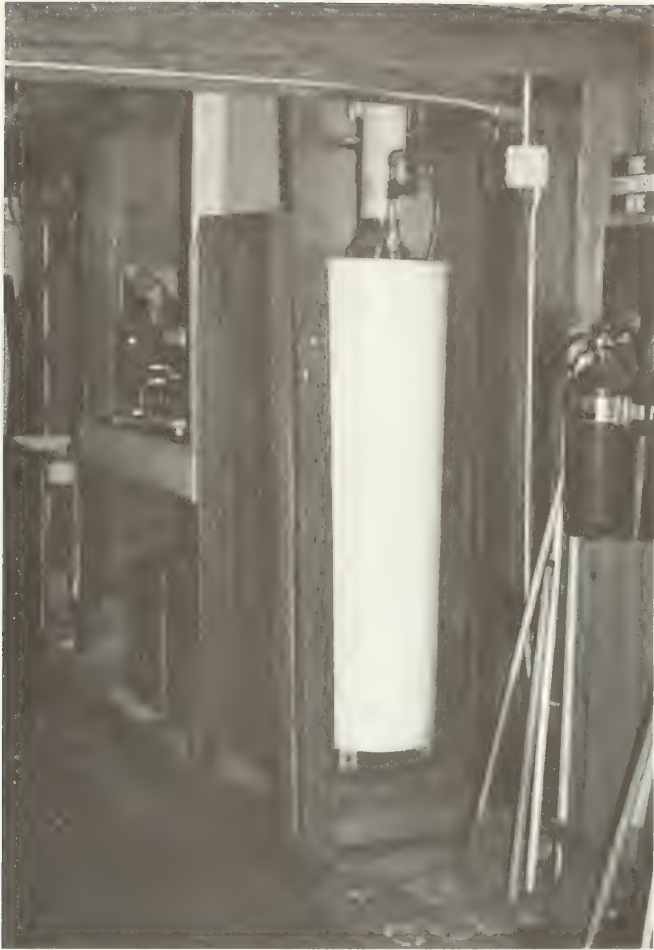
KGA-30-879, 36,000 BTUH (figure D-4). Currently it is the sole source of hot water in the market building and serves one employee sink in the market section (figure D-1), and one employee sink and a triple bar sink in the bar section of the building. It is adequate for present uses but should be replaced to serve intended loads at the time of the building rehabilitation. An electric model would likely replace this unit assuming the propane is removed. The water pipe is partly covered by old style insulation, which is in bad shape (figure C-6). A sample was collected and sent to a lab for detection of asbestos. Test results report is included in Appendix F.

Figure D-4. Market--Water Heater (5/86).

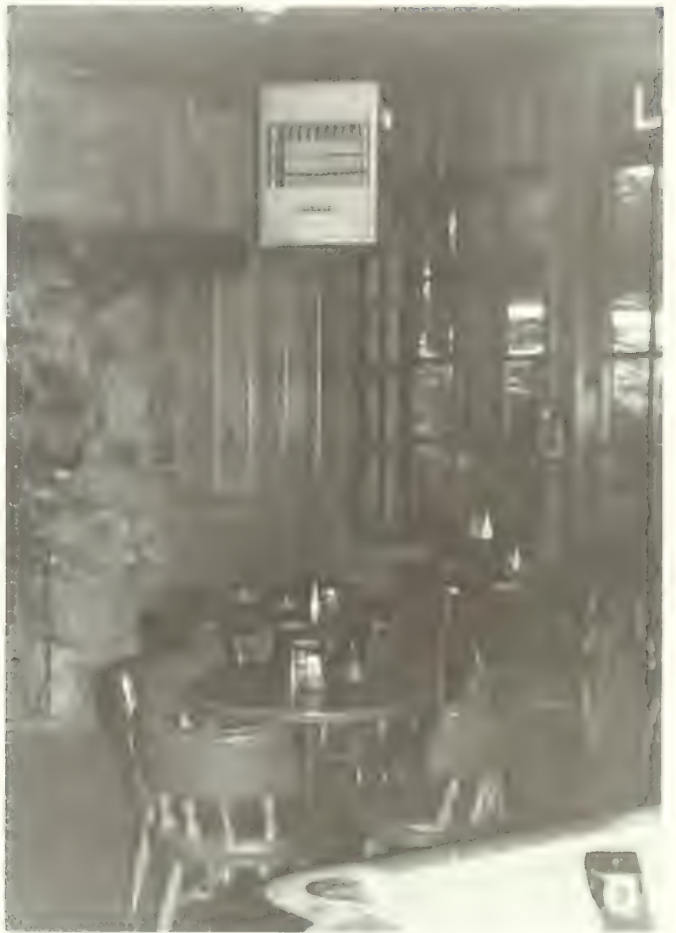
The market building is heated by three ceiling mounted propane-fired unit heaters. The plumbing system consists of three sinks and condensate waste from various coolers. The systems are adequate for current use, but should be replaced when the buildings undergo the rehabilitation planned.

Figure D-5. Market--Unit Heater (5/86).

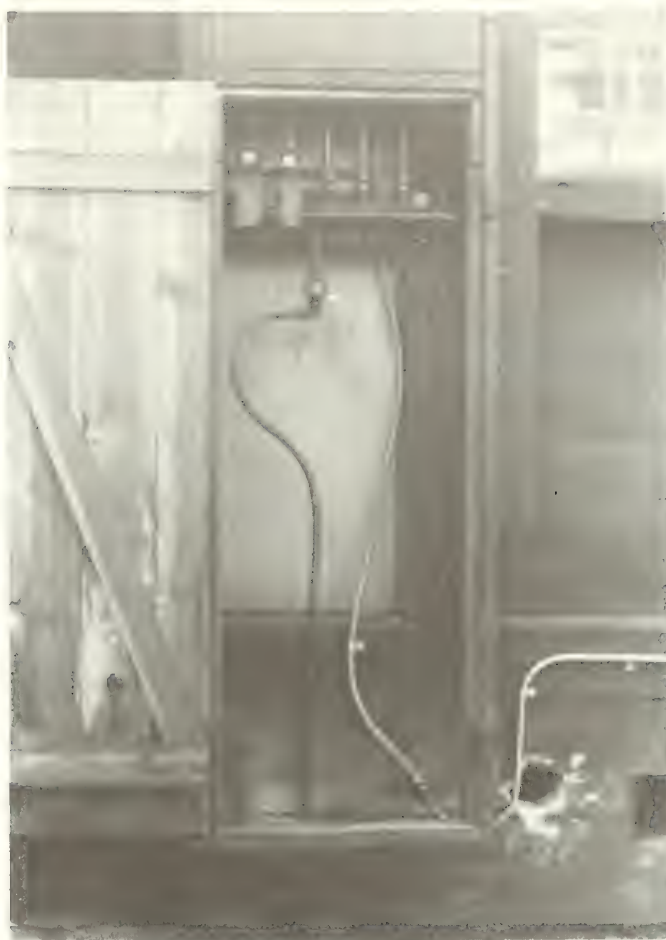
Figure D-6. Market--Propane Distribution Vault (5/86).

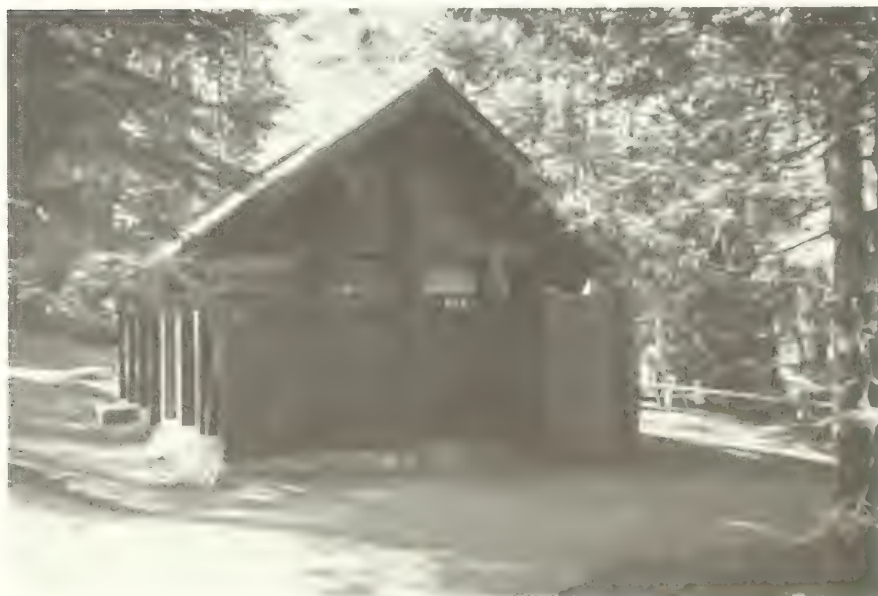
Figure D-7. Comfort Station--Auxilliary Vent Line Under Eaves (5/86).

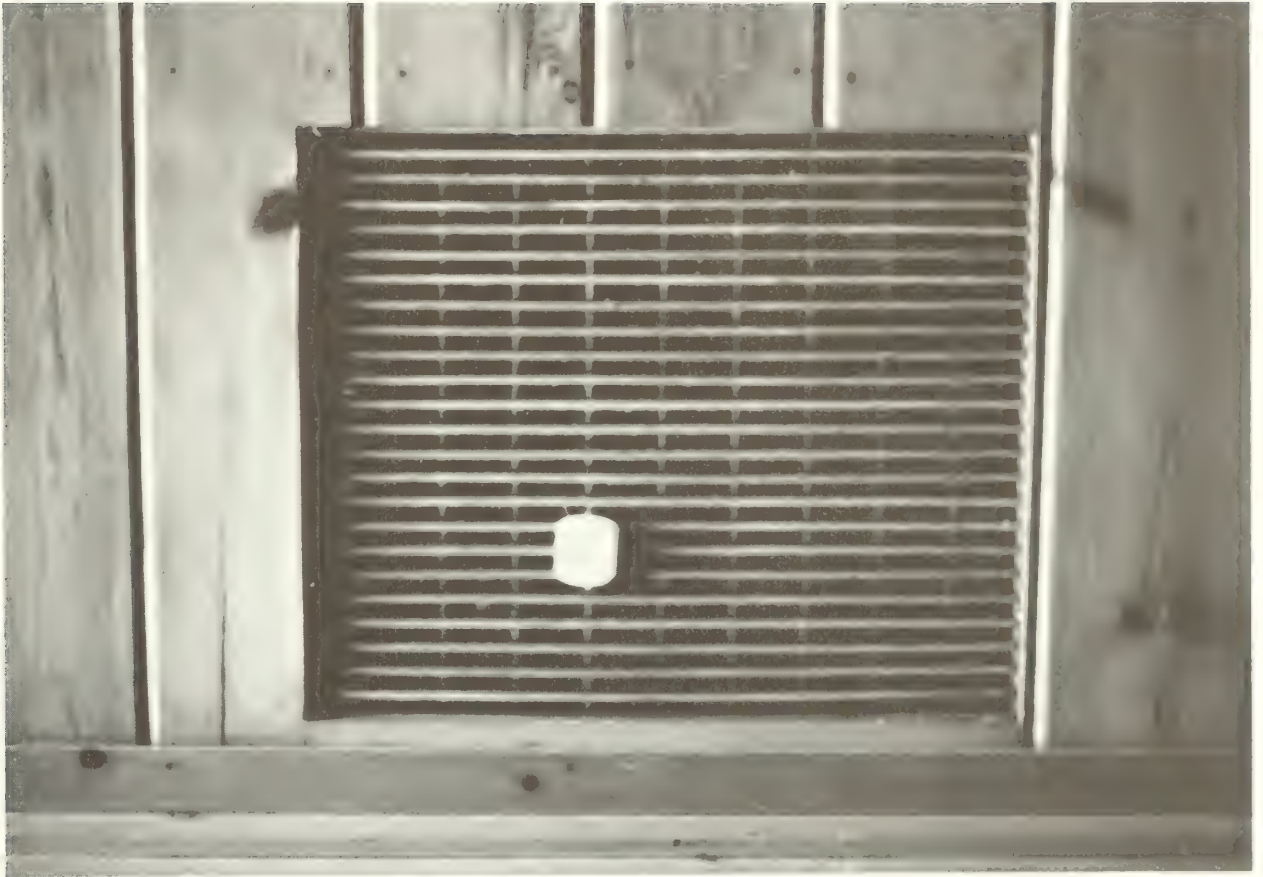
Figure D-8. Market--Ceiling Mounted Wooden Ventilation Grill (5/86).

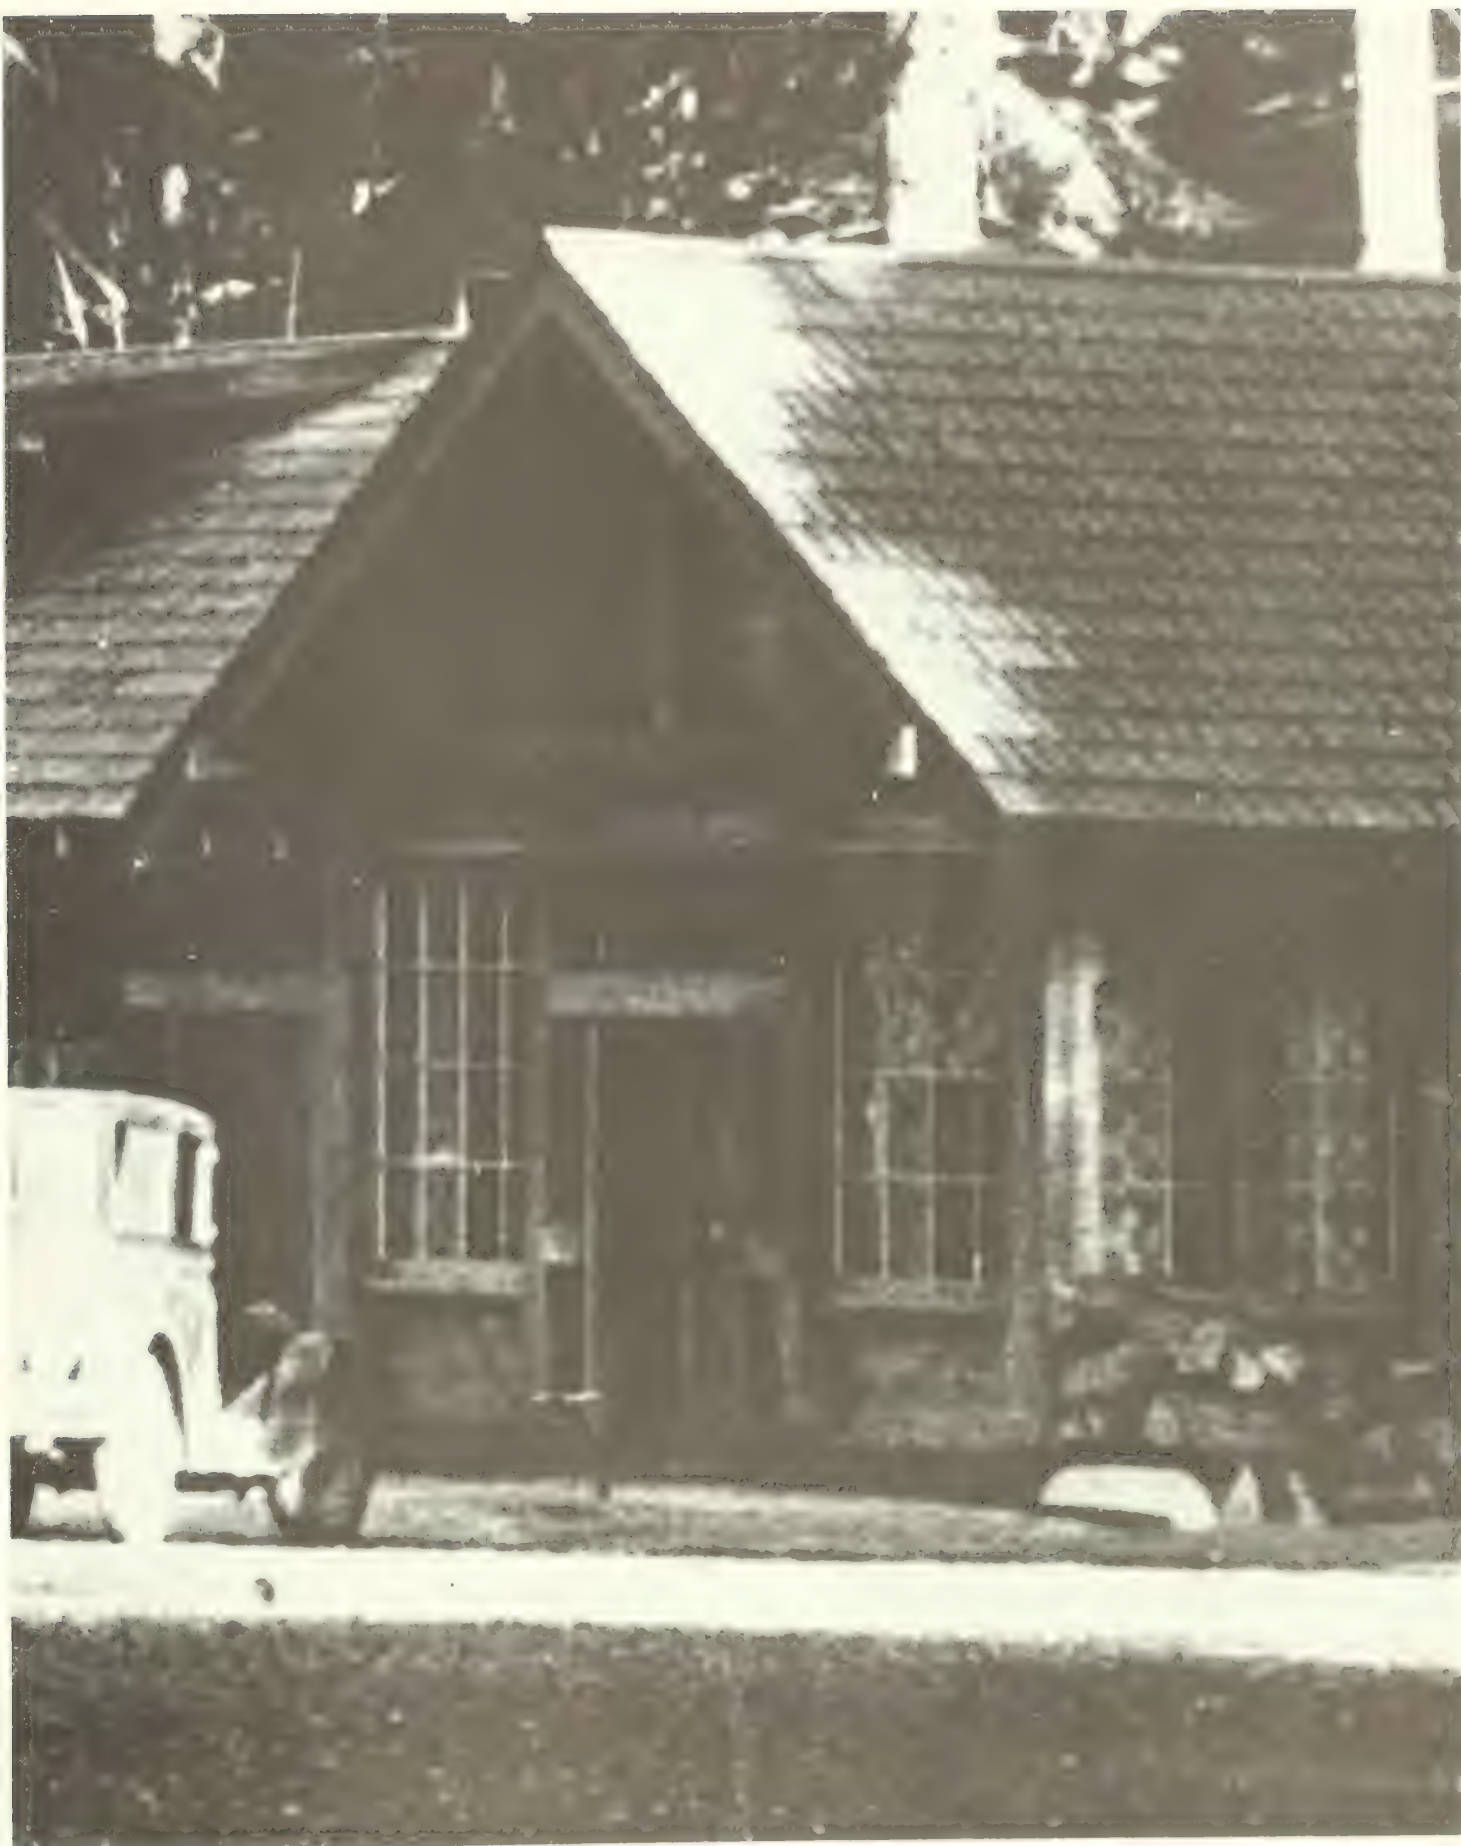
Figure H-1. South wing of Market (1932). This view is a blow-up of that portion of figure 16 which best illustrates the fenestration of the gable end of the south wing during the 1930s. (Photo by Lindley Eddy; SEQU archives #03153)

The restoration of the gable end of the south wing to its 1930s appearance can certainly be done; but, an examination of the following listing of advantages (pros) and disadvantages (cons) reveals the basis for the recommended approach.
